NONDESTRUCTIVE EVALUATION OF GRAPHITE/EPOXY COMPOSITE DAMAGE

S. W. Schramm, I. M. Daniel, and W. G. Hamilton
IIT Research Institute
Chicago, Illinois 60616

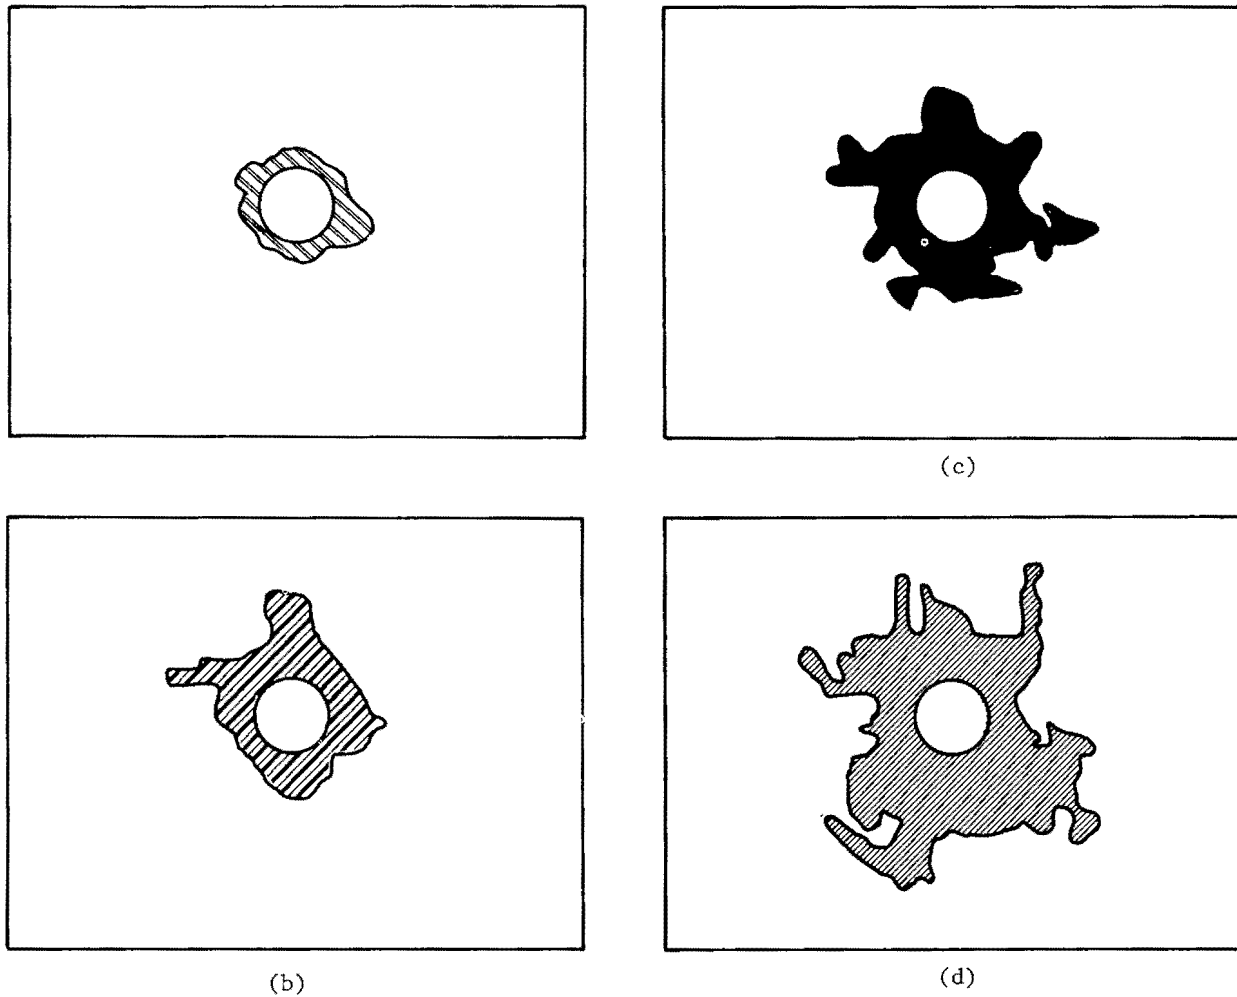
Fig. 5

Acoustic Emission² - Figure 5 shows flaw maps of the cumulative damage through 0, 4, 8, and just before 10 lifetimes, respectively. As was seen for other specimens with this initial flaw type,¹ the flawed area increased in a generally radial pattern around the hole at a nearly uniform rate. The damage indicated in Fig. 5a is associated with the fiber breakage caused when the hole was machined. The rapid

Cumulative Flaw Growth Under Fatigue Loading in $[(0/\pm 45/90)_s]_2$ Graphite/Epoxy Specimen with Circular Hole. (a) Initial Flaws, (b) Four Lifetimes, (c) Eight Lifetimes, and (d) Nearly Ten Lifetimes

acceleration of the flaw damage between Figs. 5c and 5d was expected because the maximum testing stress of 223 MPa (32 ksi) specified in the initial program for this material was exceeded. The maximum peak stress of 276 MPa (40 ksi) was applied at the end of eight lifetimes of testing and maintained until failure, which occurred very near the end of the tenth lifetime (1, 274, 428 cycles).

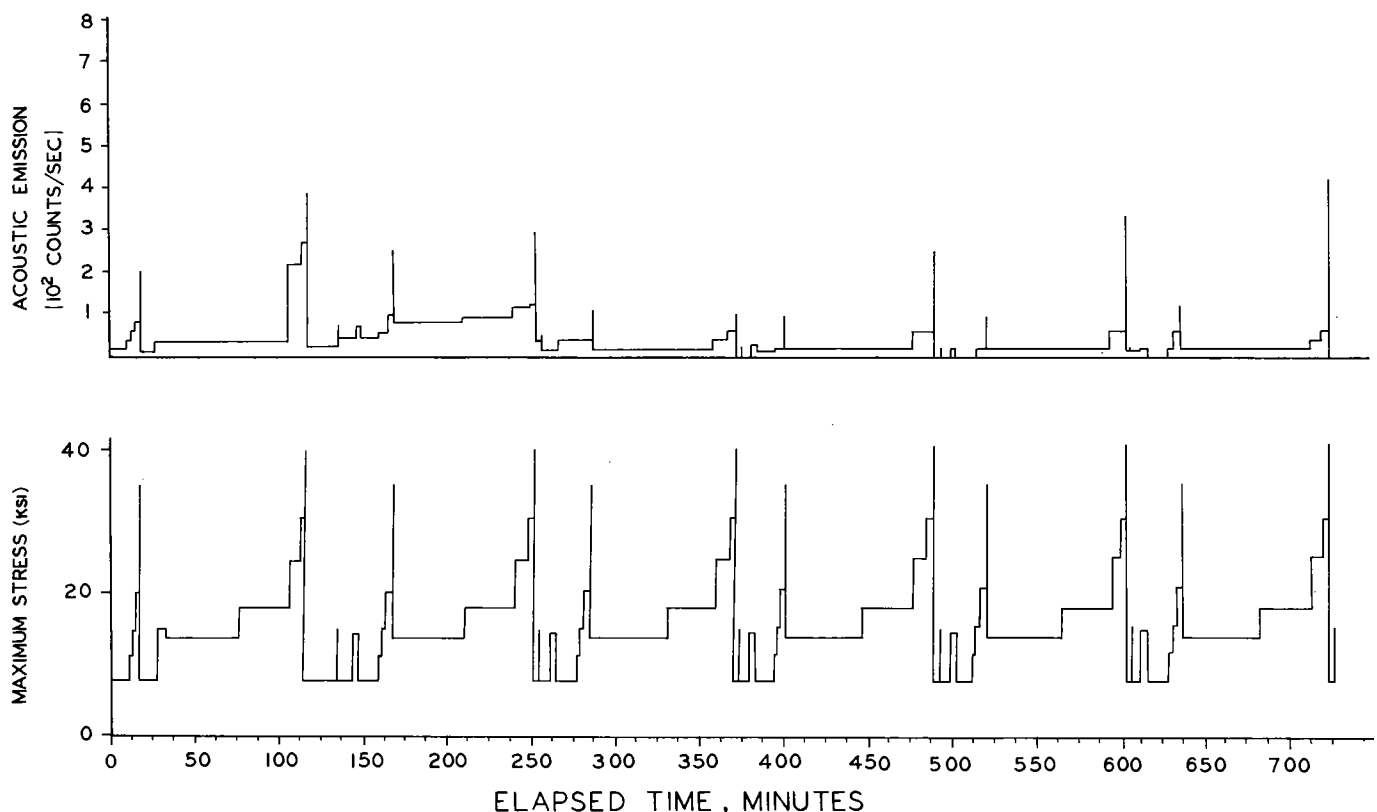
Figure 6 shows a general increase in the acoustic emission response at peak loads while the response to low load applications decreases during the 9th lifetime. Acoustic emission activity increases generally after 8½ lifetimes up to a point where a large amount of activity is recorded culminating in a massive burst (arrow in Fig. 7). Close examination of the specimen after the 19th half-lifetime showed the presence of a large delamination visible on the boundary of the circular hole. Since no sign of such damage was present before the 19th half-lifetime it has been concluded that the formation of the delamination coincided with the acoustic emission burst. Since the specimen failed before completion of the half lifetime following the one where the massive burst occurred, it is safe to say that the acoustic emission indicated, if not predicted, that failure was imminent.

Fig. 6
Acoustic Emission and Corresponding Load Spectrum for $[(0/\pm 45/90)_S]_2$ Graphite/Epoxy Specimen with Hole for 8½ and 9 Lifetimes

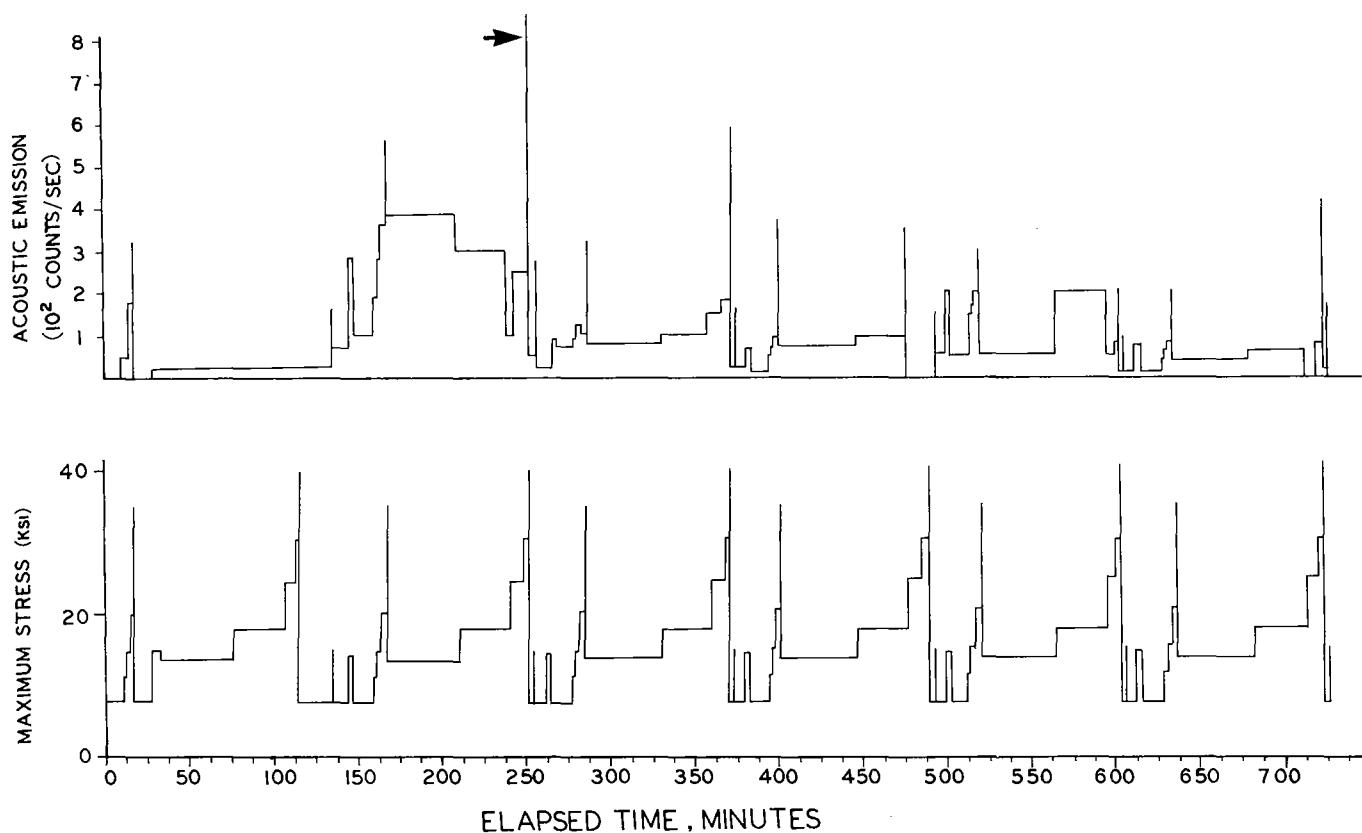
Fig. 7

Acoustic Emission and Corresponding Load Spectrum for $[(0/\pm 45/90)_5]_2$ Graphite/Epoxy Specimen with Hole for $9\frac{1}{2}$ and 10 lifetimes

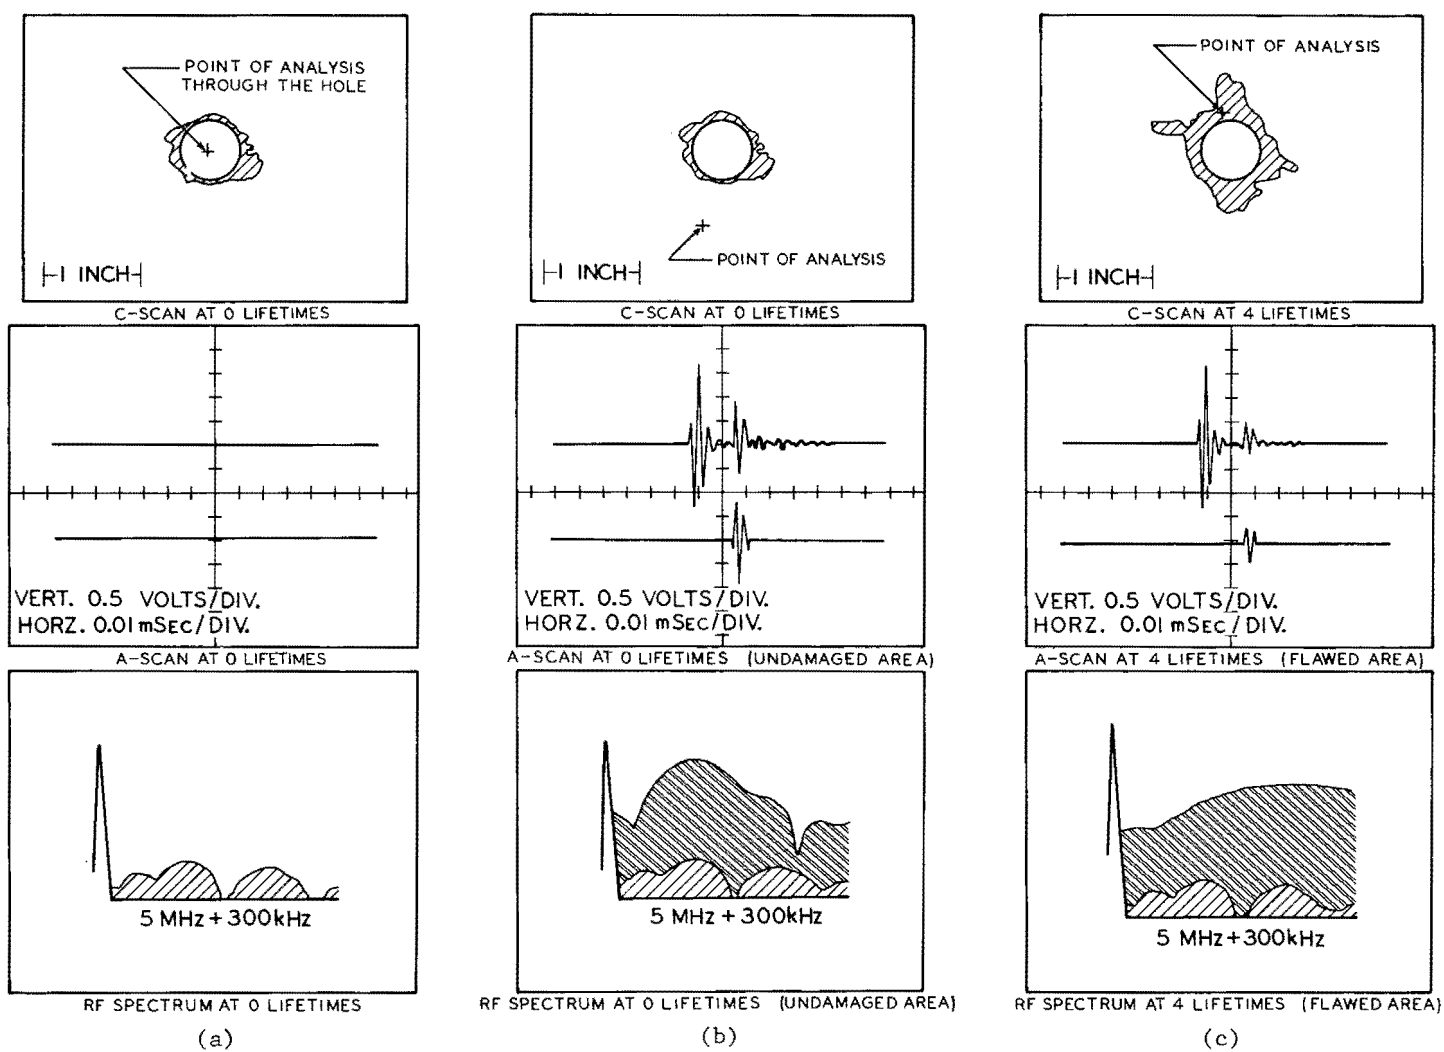
Ultrasonic Monitoring - Figures 9, 10, and 11 show representative C-scan, A-scan and RF spectrum data for the test specimen at the indicated inspection times. Figure 9a shows the baseline responses of the A-scan and RF spectrum when no material is seen by the ultrasonic wave. The scatter on the RF spectrum is due to feedback noise from the A-scan oscilloscope. Figure 9b shows the baseline A-scan and RF spectrum responses when the ultrasound passes through an undamaged section of the specimen.

Fig. 9
Ultrasonic Inspection Data at the Indicated Point of Analysis After
(a) 0, (b) 0, and (c) 4 Lifetimes of Load Application

of the ultrasonic wave. For 16-ply graphite/epoxy specimens, the alarm voltage window, indicating no material damage, was 1.5 to 3.5 volts. In Fig. 9b the back-face reflection amplitude is slightly greater than 1.5 volts indicating undamaged material. When the specimen was inspected at the end of $5\frac{1}{2}$ lifetimes, the back-face reflection amplitude had decreased to a value of approximately 0.25 volts. The decrease to 0.25 volts took place in increments of approximately 0.25 volts per inspection. This implies that the severity of the material damage, which was determined to be a delamination in post-failure analysis, increased slowly as the fatigue cycles accumulated. The amplitude of the back-face reflection is of such a magnitude at the $5\frac{1}{2}$ lifetime inspection that the delamination had formed, but was still tight enough to allow passage of the ultrasound between the two adjoining plies.

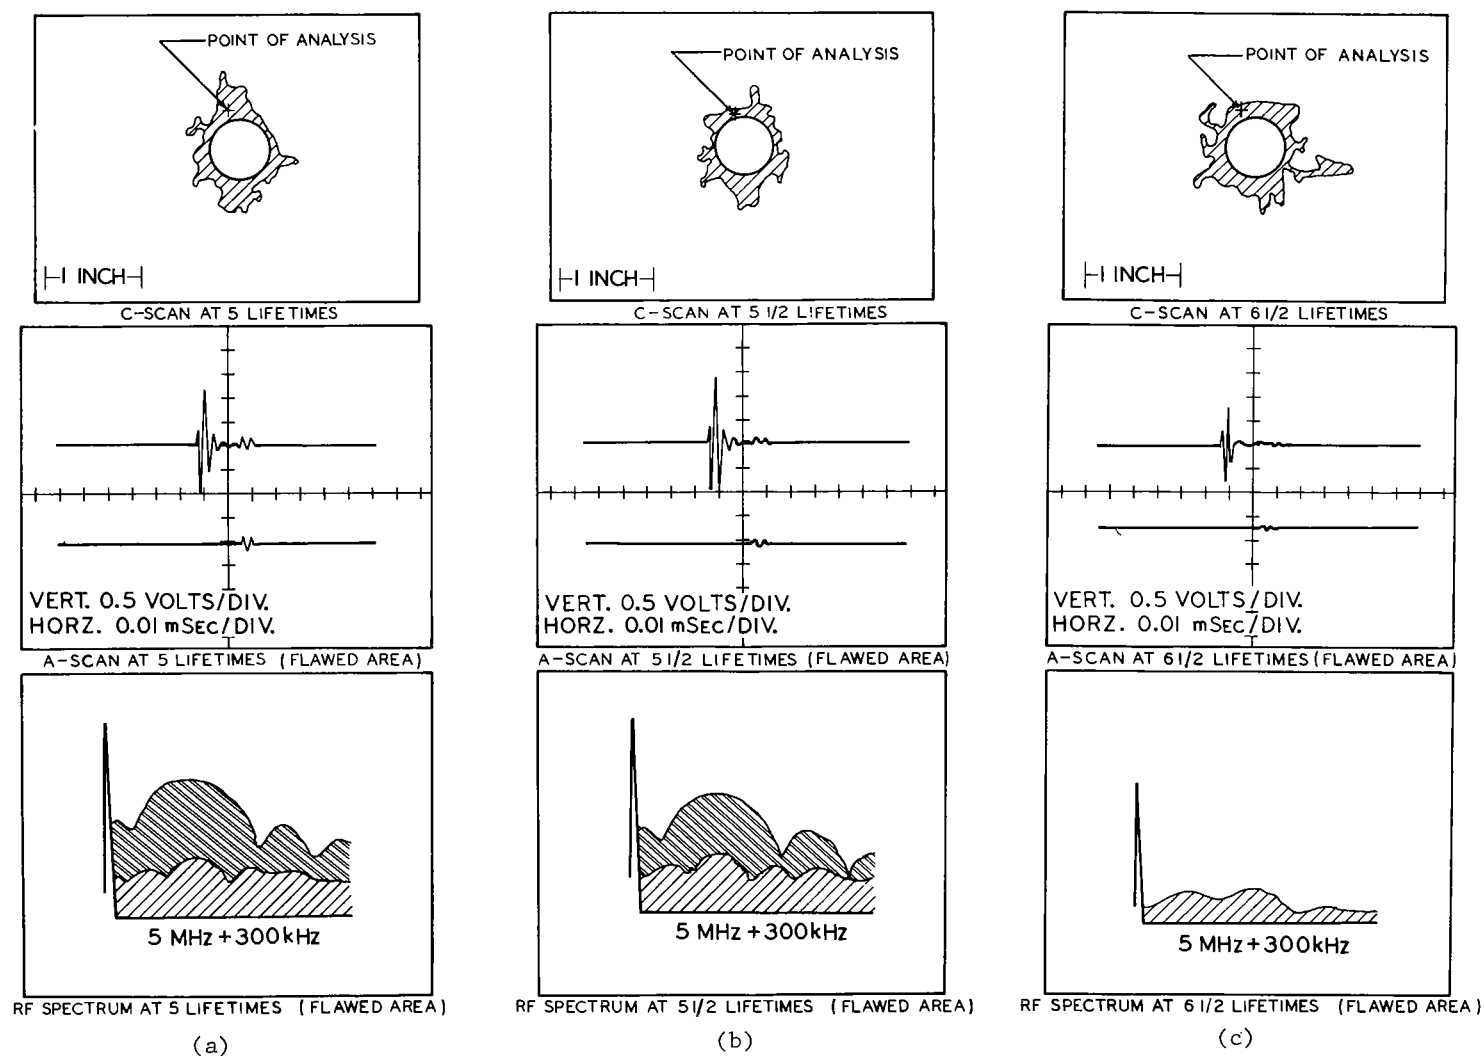
Figure 9c through 11b show how the A-scan and RF spectrum change as fatigue cycles are accumulated. C-scan inspections at 4, 5, and $5\frac{1}{2}$ lifetimes (Figs. 9, 10a, and 10b, respectively) indicate little damage growth in the area of the point of analysis. In contrast, the A-scans and RF spectra have changed appreciably from those in Fig. 9 indicating a definite change in the material integrity near the point of analysis. The characteristic which indicates the material degradation is the back-face reflection of the A-scan wave. The level of ultrasound attenuation, which indicates the presence and severity of an abnormality in the material, is represented by a change in the amplitude of the back-face reflection,

Fig. 10
Ultrasonic Inspection Data at the Indicated Point of Analysis After
(a) 5, (b) 5½, and (c) 6½ Lifetimes of Load Application

By the $6\frac{1}{2}$ lifetime inspection, Fig. 10c, and up through the 9 lifetime inspection, Fig. 11a, only a faint back-face reflection amplitude can be seen. During this period it has been determined, using additional data not presented herein, that the delamination began to progress transversely across the

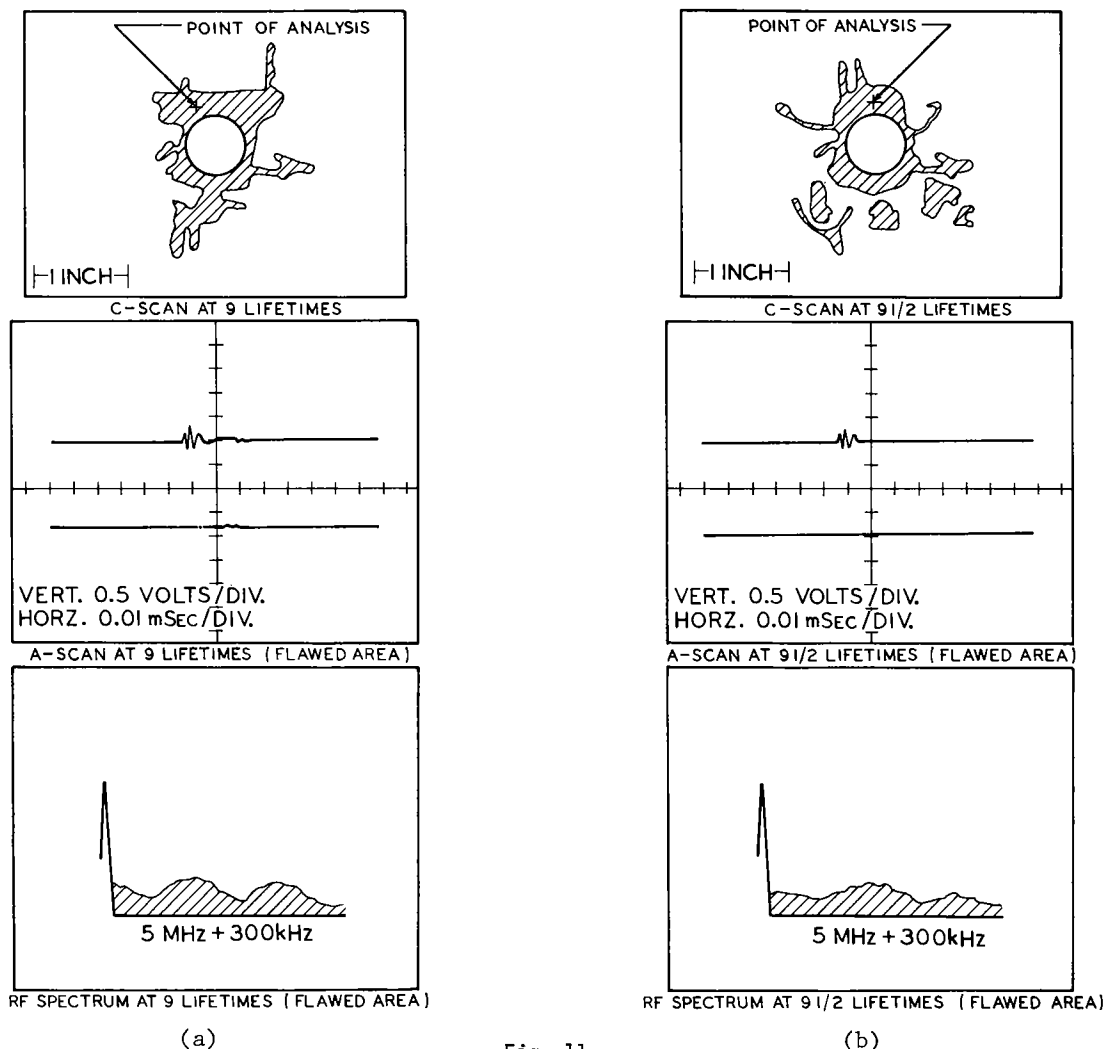
Fig. 11
Ultrasonic Inspection Data at the Indicated Point of Analysis After
(a) 9 and (b) $9\frac{1}{2}$ Lifetimes of Load Application

specimen from the hole towards the free-edge. This is evidenced by the tendrils of flawed area shown in the C-scan at the completion of 9 lifetimes of cycling, Fig. 11a. When the specimen was inspected after $9\frac{1}{2}$ lifetimes the delamination was severe enough that the ultrasound could not pass across the gap, hence, no back-face reflection was evident. The extent of the area of damage after 9 lifetimes (C-scan Fig. 11a) and the severity of the damage after $9\frac{1}{2}$ lifetimes (A-scan Fig. 11b) given adequate warning of the failure which occurred during the twentieth half-life of cycling. Similar trends are present in other areas of the specimen near the hole, but the volume of data required to show these trends would be extremely high. During the course of the investigation forty-one C-scans, 316 A-scan/RF spectrum photographs, and 120 feet of acoustic emission data was generated for this single specimen.

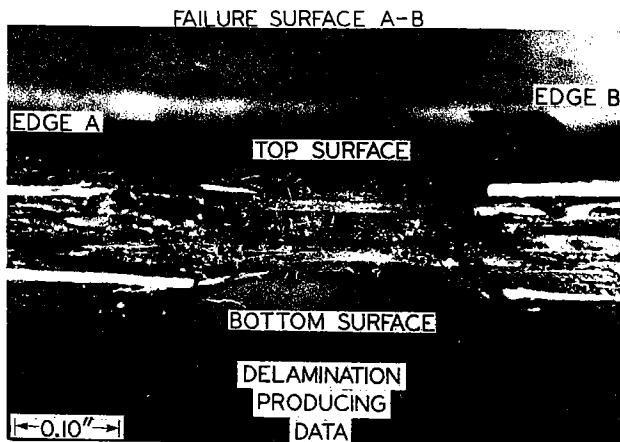
The photograph (Fig. 12) shows the failed specimen after removal from the fatigue chain. The massive delamination shown on the photo labeled "Failure Surface A-B" was the source of the data presented above. Presently, additional work is being done to correlate C-scan/A-scan/RF spectrum

Fig. 12
Failed Specimen After Removal
From Fatigue Chain
